Manhole Inspection Summary

Manhole # S51M__026MH

Insp Date: **4/8/08 9:22 AM**

Location Address: **hudson st**

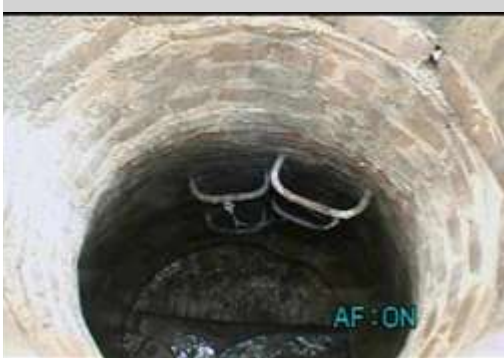
Defect

Count: **5** Missing: **0** ☒ **Corroded**

corroded steps

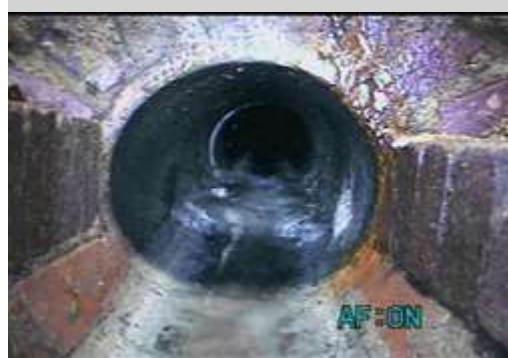
Defect

Infiltration: ☐ None ☐ Joint ☐ Cracks ☐ Mortar ☐ Roots ☒ **Wall**

barrel infiltration

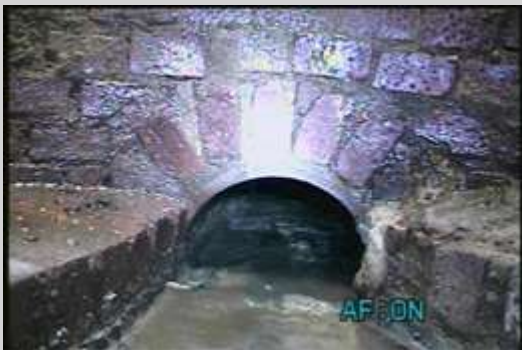
12 O'Clock Outflow

8 in. Circular Gravity Sewer
Pipe Out @ 12 O'Clock

Infiltration: **None** Pipe Seal Cond: **Unknown**

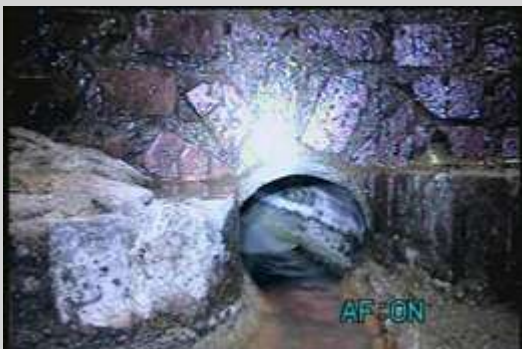
3 O'Clock Inflow

10 in. Circular Gravity Sewer
Pipe In @ 3 O'Clock

Infiltration: **None** Pipe Seal Cond: **Unknown**

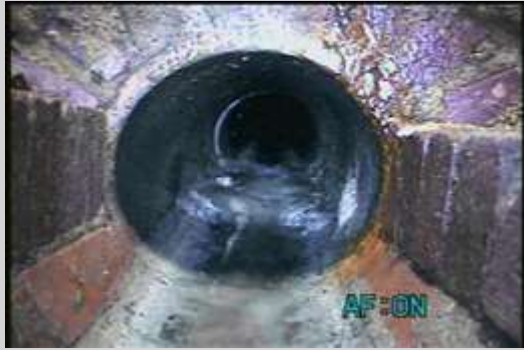
9 O'Clock Inflow

10 in. Circular Gravity Sewer

Pipe In @ 9 O'Clock

Infiltration: **None** Pipe Seal Cond: **Unknown**
